*Environmental engineering and ecological  
baseline investigations along the  
Yukon River-Prudhoe Bay Haul Road*

CRREL Report 80-19

Jerry Brown and Richard L. Berg, Editors

September 1980

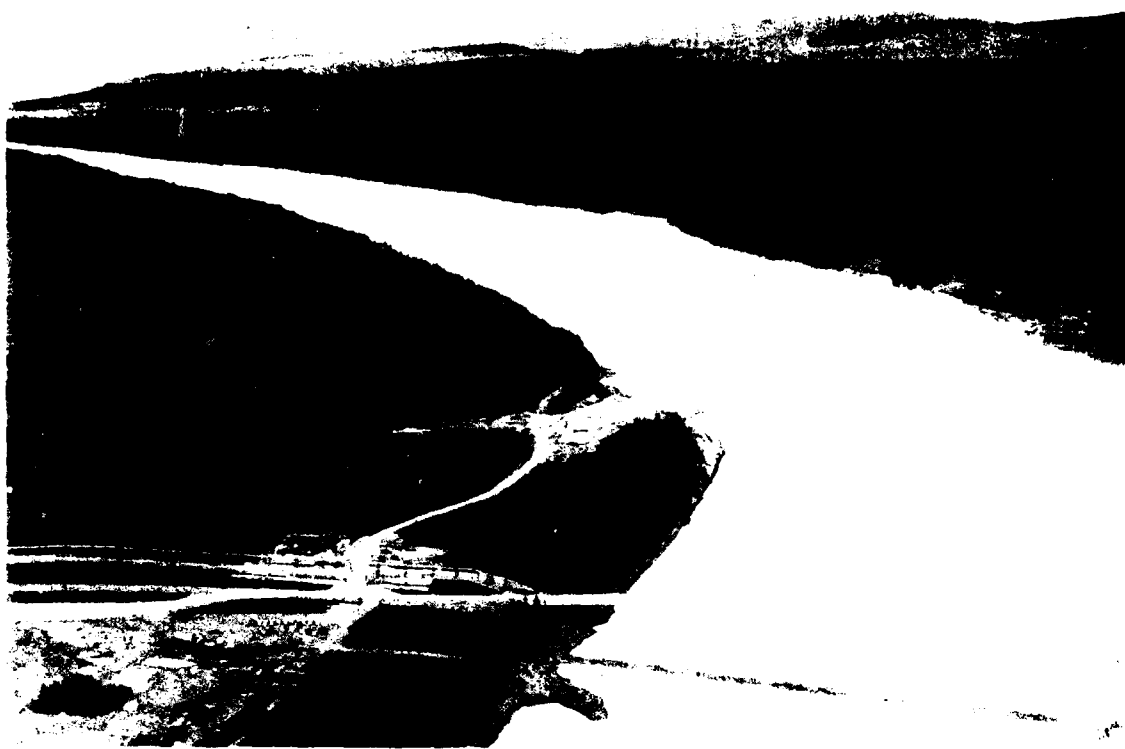
Figure 2. Beginning of the Haul Road on north bank of the Yukon River, 11 August 1976.

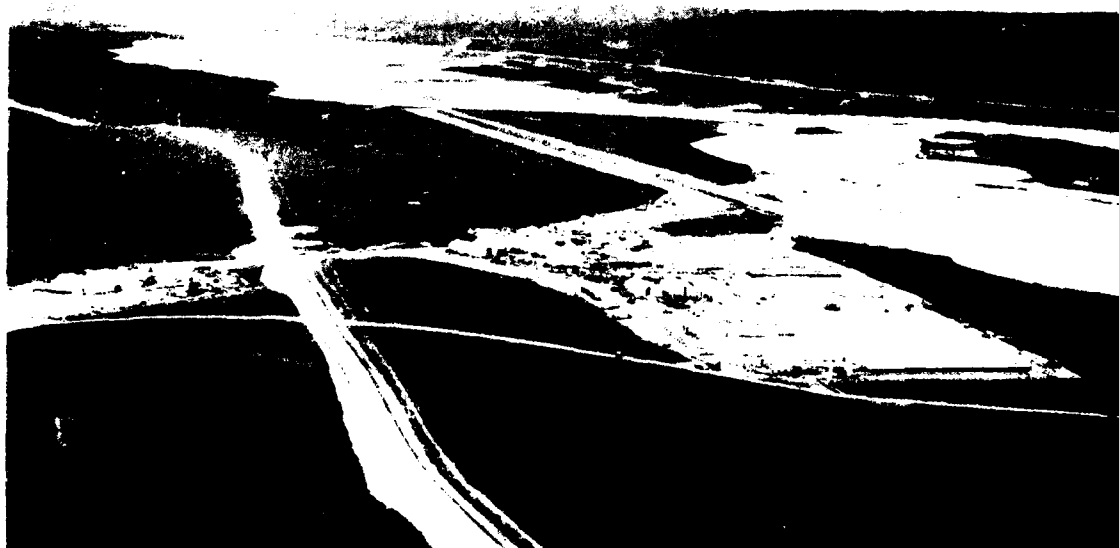
Figure 8. Road crossing foothills between Happy Valley Camps, 11 August 1976. Sagavanirktok River is to the east. The gravel-filled fuel gas line trench is seen adjacent to the road on the right side of this ice-rich permafrost setting. The oil pipeline is across the river.

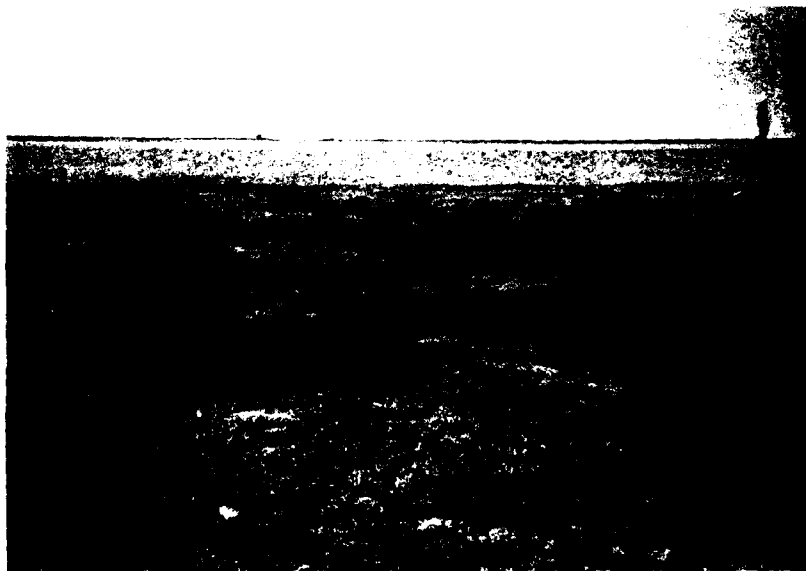
*Figure 31. Erosion channels adjacent to road at MS135-A, B, C caused by melting of ice-rich permafrost, 24 June 1976. Although the pattern resembles polygonal ground, some horizontally bedded massive ice was observed in the exposed cuts.*

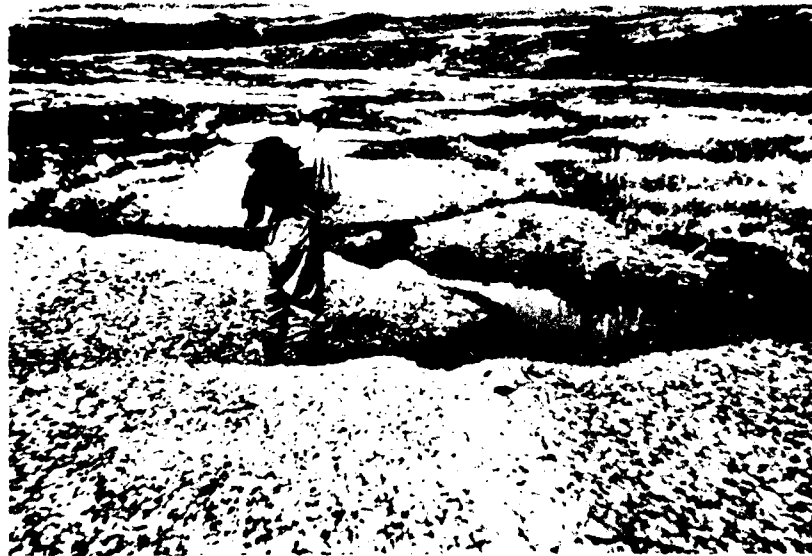
Figure 47. Gravel road showing severe differential subsidence caused by thawing of ice-wedge polygons in permafrost, Umiat, Alaska.

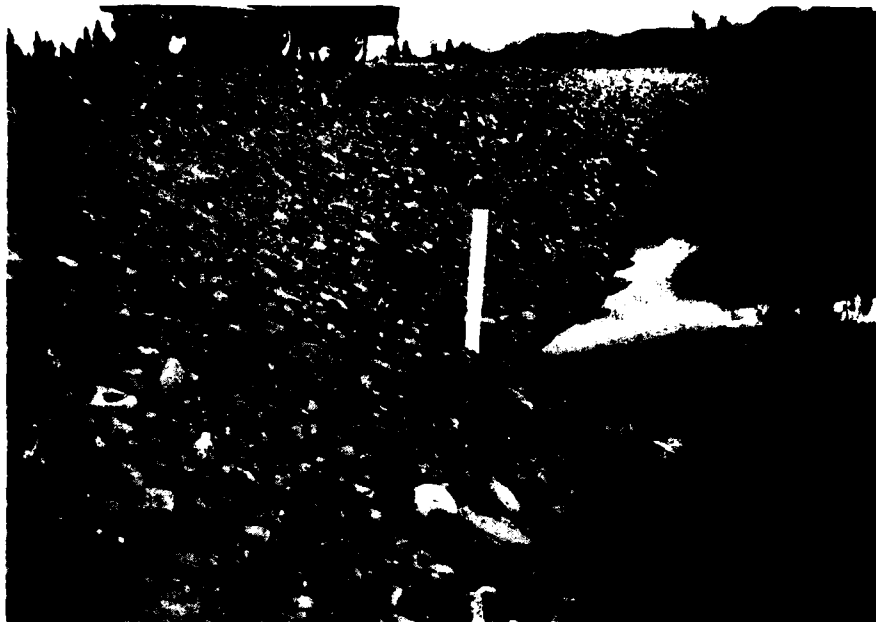
Figure 55. Upstream ponding caused by shoulder thaw consolidation and bowing of the culvert, site 91-C1, August 1977.

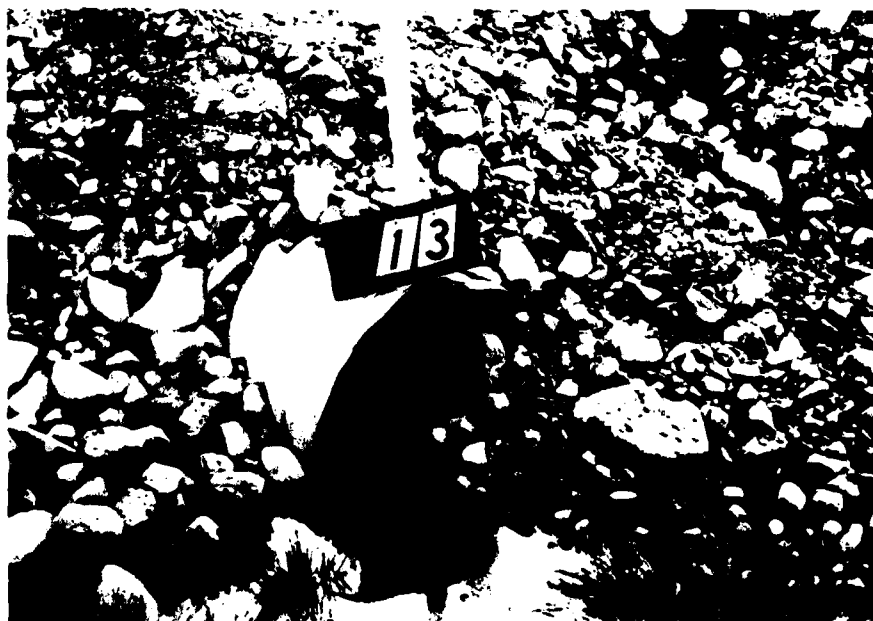
Figure 56. "Maintenance clogging" problem caused by surface material graded down sideslope of road, site 91-C2, August 1977.

4. The most frequent problem related to cross drainage was observed to be "maintenance clogging" of culverts. The problem is caused when short culverts are partially or entirely blocked by gravel pushed downslope from frequent grading, thereby preventing water movement through one or both ends of the culvert.

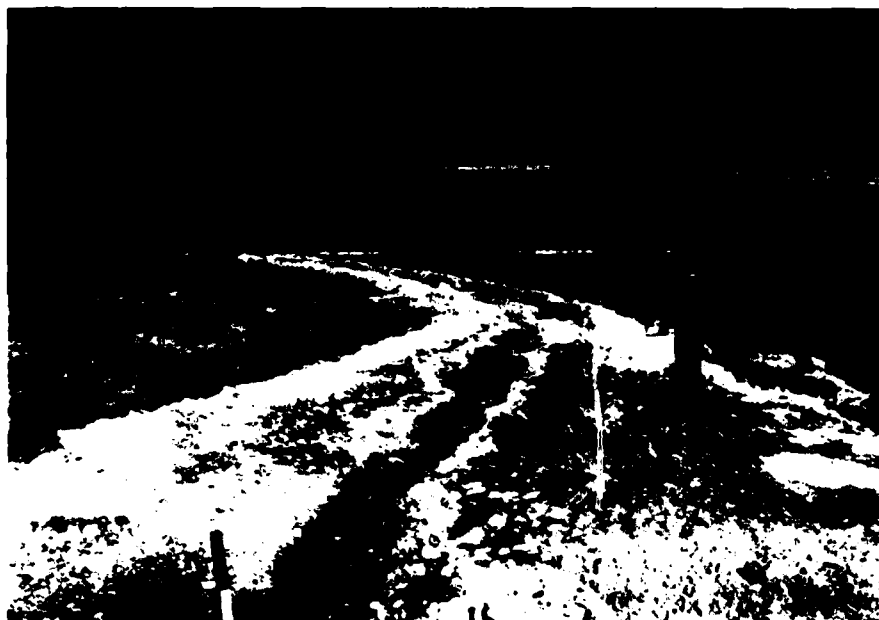
Figure 58. Drainage channel constructed to minimize additional thermal erosion downslope from the road, site 102-C1, August 1977.

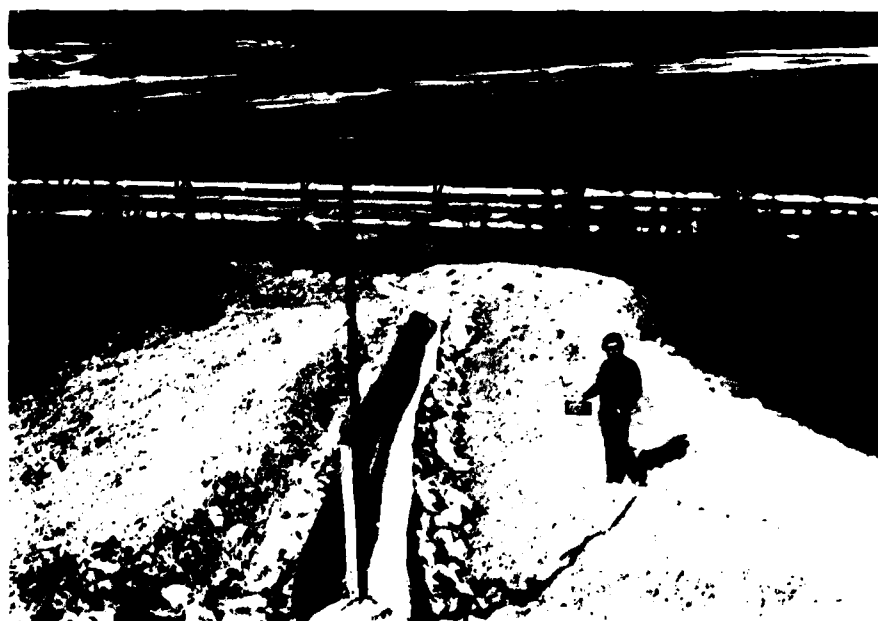
Figure 59. Half sections of corrugated metal pipe (CMP) used to channel water downslope from culvert. The CMP sections were over a granular fill placed in a gully caused by thermal erosion, site 102-C6, August 1977.

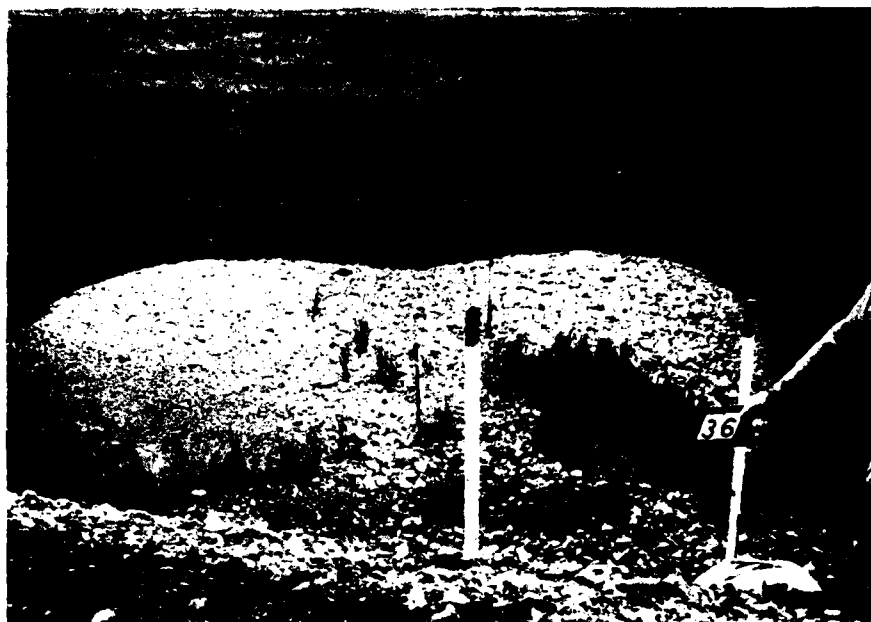
Figure 60. Debris deposit at outlet of culvert, site 132-C1, August 1977.

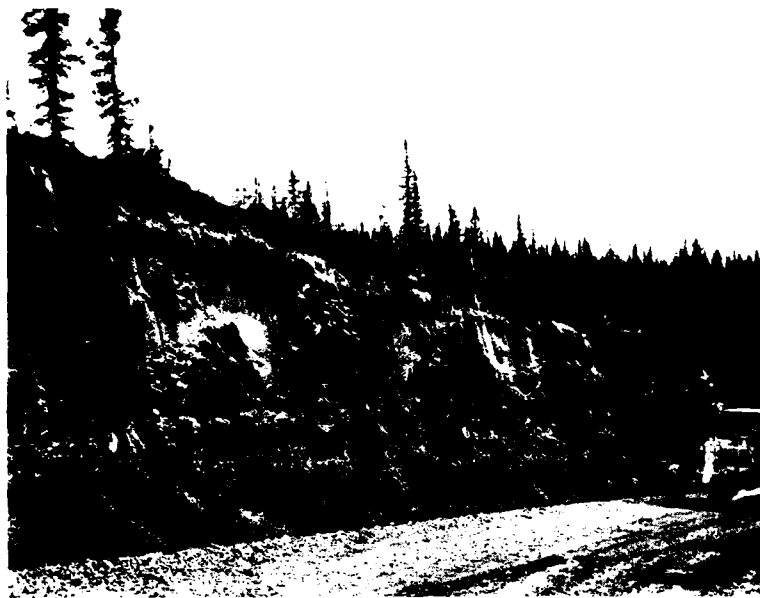
Figure 69. Frozen, nearly vertical backslope exposing large ice masses, left side of TAPS Road, mile 20.25 on 23 April 1970, (from Berg and Smith 1976).

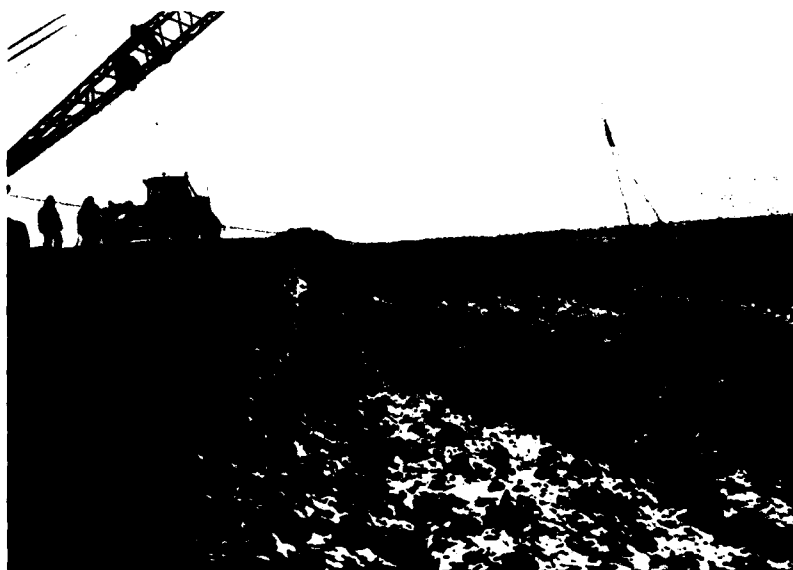
Figure 84. Crane with clam bucket scraping debris from snowpad. This equipment was also used to place backfill over the trench from the road during the summer.

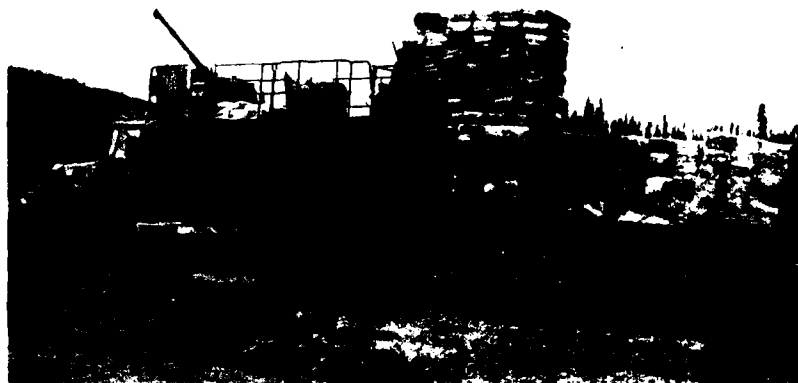
*Figure 105. Hydroseeder, with bales of wood cellulose fiber on trailer*

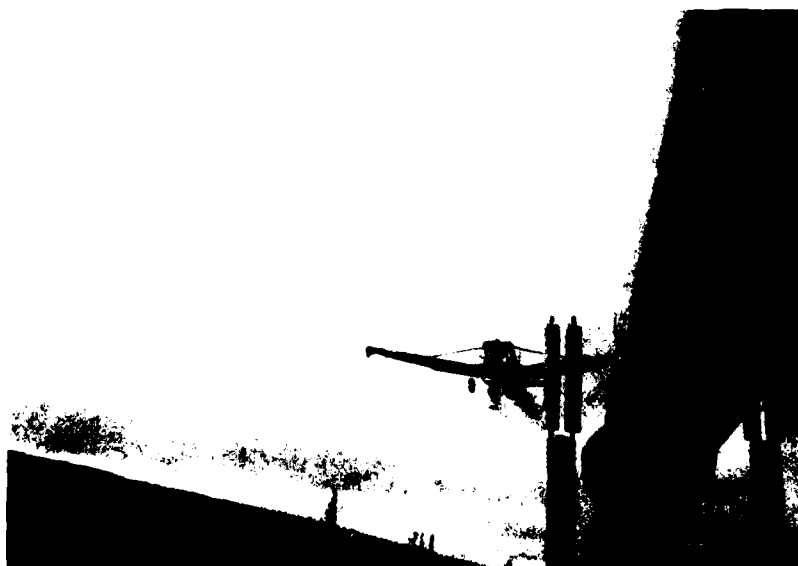
*Figure 106. Aerial fertilizing of pipeline workpad in the vicinity of Old Man, September 1976.*

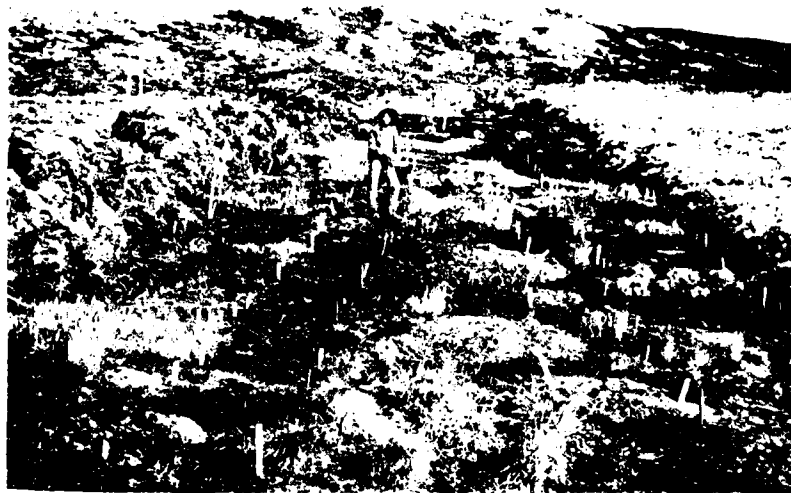
Figure 114. Experimental restoration site (MS 117-1, 2). Note growth of cottongrass tussocks (sod) and reseeded plots in foreground (13 August 1978).
